City of Lynn & Town of Swampscott, MA

# King's Beach UV Pilot Study

October 2025

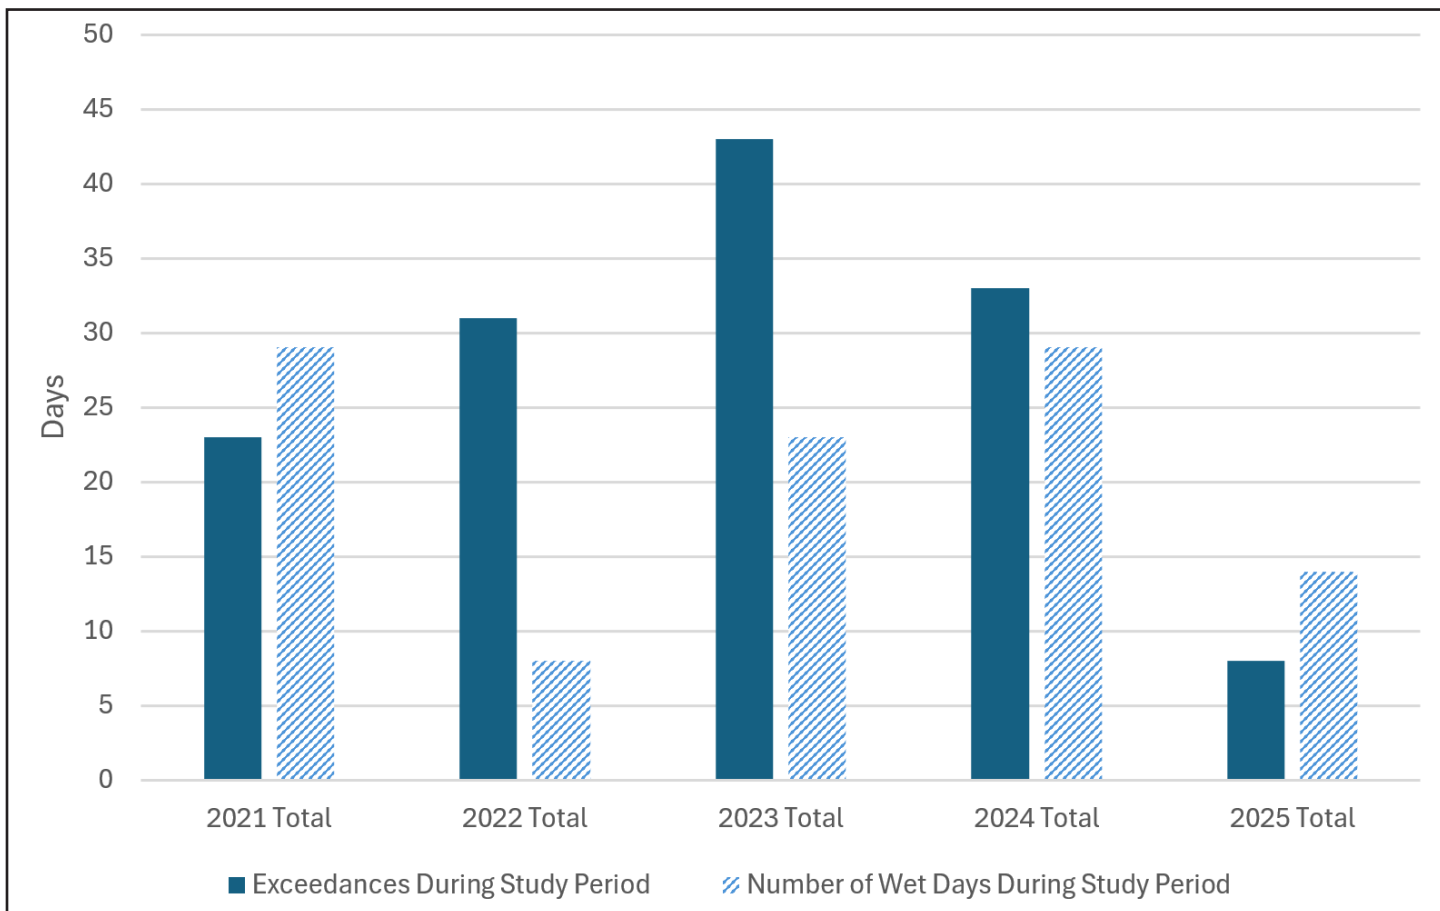
**Figure 13. Eastern Avenue Bacteria Exceedances (above 104 CFU / mL) and Wet Weather 2021-2025**

To better understand the potential impact of the UV Pilot on Eastern Avenue individual sample exceedances, historical data from the past 5 years was analyzed for the same duration that the pilot was operational. The Kimball Road and Pierce Road results, as well as the geomean calculation are not considered to isolate for the impact on water quality in the vicinity of the UV Pilot. **Table 2** includes the dates of June 20 to August 17 for each year from 2021 to 2025. Data includes the number of exceedances at the Eastern Avenue sample locations, total rainfall, and number of wet weather days. Exceedances include the number of single sample results over the 104 CFU / 100mL threshold. The data is subdivided into months and totaled for the entire period. Additionally, a plot with the exceedances and wet weather days for each year is included in **Figure 13**. Note that the 2025 data includes the full 59-day operational period including days when the pilot was partially and fully offline.

Many factors may contribute to the concentration of bacteria in the ocean at the Eastern Avenue testing location at King’s Beach. However, when comparing the exceedances in 2025 during the UV operation to the previous 4 summers, it had a meaningful impact. Note that as mentioned above, these totals do not account for days when the UV pilot was partially and fully offline. The period of UV operation was significantly drier than previous summers apart from 2022, which had a similar number of wet weather days. However, there were only 8 counted exceedances at Eastern Avenue in 2025 compared to 31 in 2022.

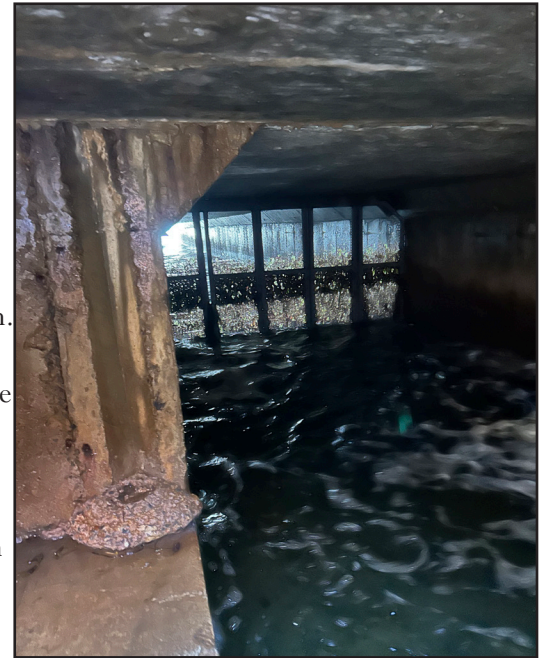
**Figure 15. Culvert Screen Installed to Manage Seaweed**

Tidal and ocean impacts were expected prior to the UV Pilot due to the proximity of the ocean and the high tides that intrude up the culverts. During most high tides, the peak water level exceeded the height of the 3-foot weir walls. However, the extent of the tidal impacts was greater than expected. At the initial startup of the pilot, the pumps became critically clogged within one day due to large amounts of seaweed being washed up and over the weir walls. Incidentally, the initial startup occurred shortly after a large Nor'easter offshore that likely increase the volume of seaweed washing up on King's Beach. The startup had to be temporarily paused until a solution was identified to reduce seaweed washup. Ultimately, metal screens with 0.5-inch openings were installed in both culverts downstream of the weir walls to protect the pilot equipment from seaweed. The screens helped significantly and the pilot would not have been successful without them; however, seaweed issues persisted throughout the pilot. **Figure 15** shows a view of the screen from the upstream perspective.

Regular maintenance was conducted to remove seaweed from the pumps, piping, UV system, and screens to ensure equipment could operate continuously. Additionally, regular beach raking (2-3 times per week) was completed on the Swampscott side of King's Beach to clear seaweed and debris. However, the beach raking did not include the Lynn side of King's Beach or the area right in front of the outfalls since this area falls under DCR's jurisdiction. Over the course of the summer, the volume of seaweed deposited on the beach varied widely. It's likely that ocean currents, storms, and other external factors offshore have a strong impact on seaweed levels; yet it's clear that seaweed is a persistent issue and must be accounted for in a permanent UV facility. **Figure 16** is an image of the Swampscott outfall full of seaweed taken during the UV Pilot. Swampscott had to remove this seaweed with backhoe.

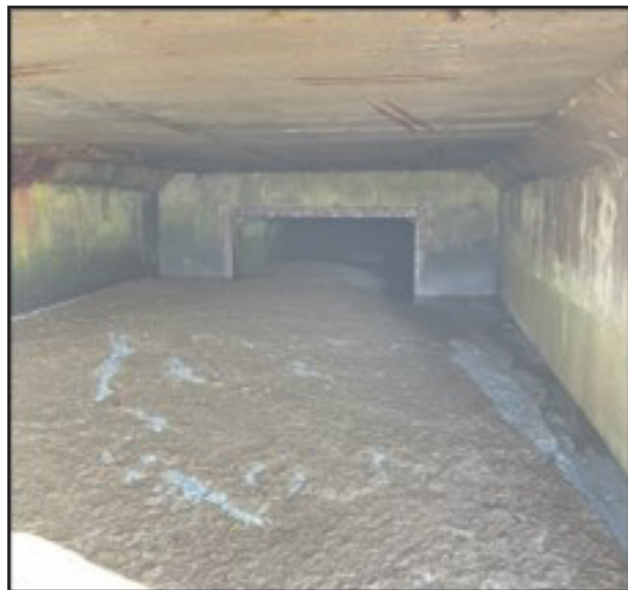
**Figure 17. Sand Buildup in Lynn Outfall**

Besides seaweed, the high tides also brought algae, organic debris, and sand into the pilot system. While these proved to be less significant hurdles than seaweed, they still required regular maintenance. Over time, the UV influent and effluent tanks accumulated debris (seaweed, algae, and organic debris) at the bottom, which had to be cleaned out periodically. Separately, sand washed up from high tide piled up significantly in both culverts between the screens and the outfalls. Sand buildup was more significant in the Lynn culvert as there

was no flow discharged during normal operation. Sand levels fluctuated, but in general, made access to the culvert from the ocean side extremely difficult. The sand also impacted flows and water levels in the culverts since the piles created pools of stagnant water that discharged slowly or only when additional flows from upstream were introduced. Cleaning of this section of culvert would be time consuming and tedious with limited access, not to mention that the sand and debris would likely return at the next high tide. **Figure 17** shows the Lynn culvert approximately half full of sand and debris during the UV Pilot.

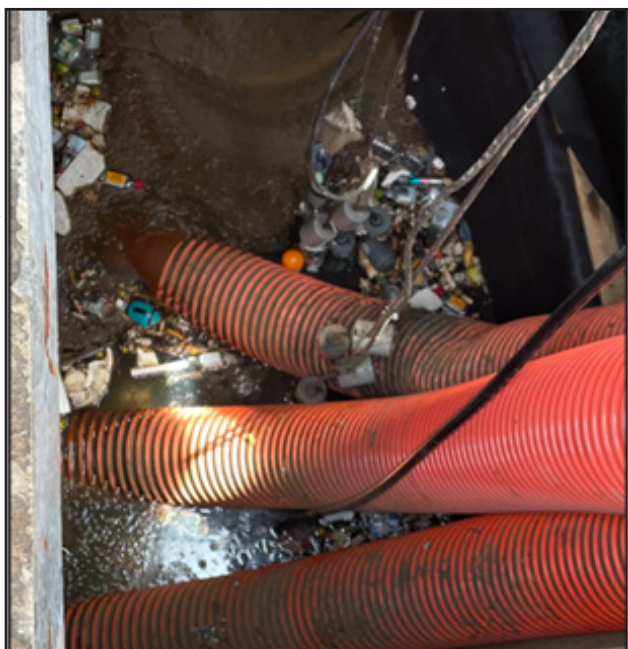
**Figure 18. Wet Weather Debris in Culvert**

Wet weather impacts on UV Pilot operation were observed throughout the summer. As discussed in the **Data and Results Section**, wet weather, especially at the start or first flush of the event, brought with it large amounts of solids and debris down the culverts from street runoff, catch basins, and other stormwater inlets. In addition to natural debris, such as leaves, sticks, and sediment, there was a significant amount of trash observed in the culverts, including plastic bottles, aluminum cans, toys, and personal items. **Figure 18** is a picture of debris floating in the culvert upstream of the weir wall after a wet weather event. The large debris usually had to be removed from the culverts and the UV influent and effluent tanks after the storm. In a permanent UV facility, additional engineering controls could be installed upstream of the treatment system to reduce the amount of solids and debris, such as screens, sediment forebays, or other pretreatment systems.

Additionally, as expected, wet weather was observed to increase flow rates in the culverts and raise water levels. The 3-foot weir walls and the metal screens installed as part of the pilot contribute head loss to the culvert flows, which has a significant impact when flow rates are high (e.g. wet weather conditions). During the pilot, head loss and backup were observed to be caused by clogging/blinding of the screens, particularly on the Swampscott side that was receiving the discharged UV effluent.

The clogging/blinding of screens was mostly caused by seaweed and other debris getting stuck in the screen mesh. Lynn and Swampscott performed regular cleaning of the screens, especially prior to a wet weather event to reduce the risk of backup; however, the cleaning did not remove all the debris. The cleaning was difficult given the limited access to the screens and the pooled water and sand accumulated on both sides. In a permanent UV facility, further hydraulic analyses should be conducted on the culverts. However, in a permanent facility the flow could be diverted to a side channel for treatment to limit the impact on the natural flow in the drains and reduce the risk of head loss and backup in the culverts.

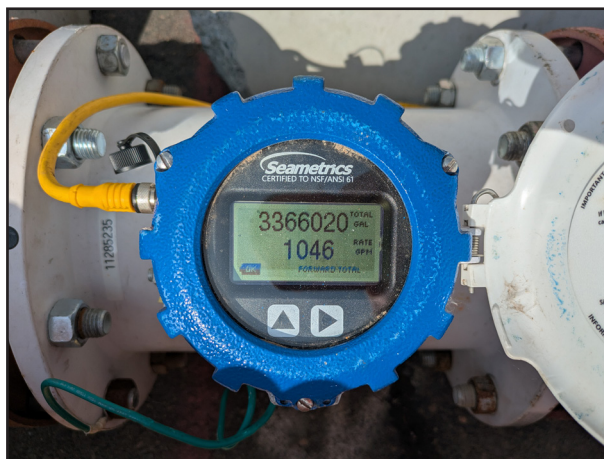
**Figure 19. Flow Meter on Pump Discharge**

The equipment used in the UV Pilot relied largely on manual monitoring and controls, which limited reliability and adaptability. The pumps were equipped with level floats for activation and Variable Frequency Drives (VFDs) that automatically controlled the flow rates for the pumps on each culvert, as shown in **Figure 19**. However, there were no automatic alarms to alert any issues (e.g. clogging, temperature, vibration, etc.). There was also no way to monitor or control the pumps remotely. To obtain the full suite of desired monitoring and controls for the pump package, the cost would be prohibitive for a temporary “pilot” setup. A permanent facility could be set up with continuous monitoring and SCADA controls.
